PHASE I INSPECTION REPORT,
NATIONAL DAM INSPECTION PROGRAM.

Water Company #4

Inspection Team - GAI Consultants, Inc.
570 Beatty Road
Monroeville, Pennsylvania 15146

PHASE I INSPECTION REPORT
NATIONAL DAM INSPECTION PROGRAM
CITIZEN'S WATER COMPANY DAM #4
NDI# PA-507, PENNDER# 63-3

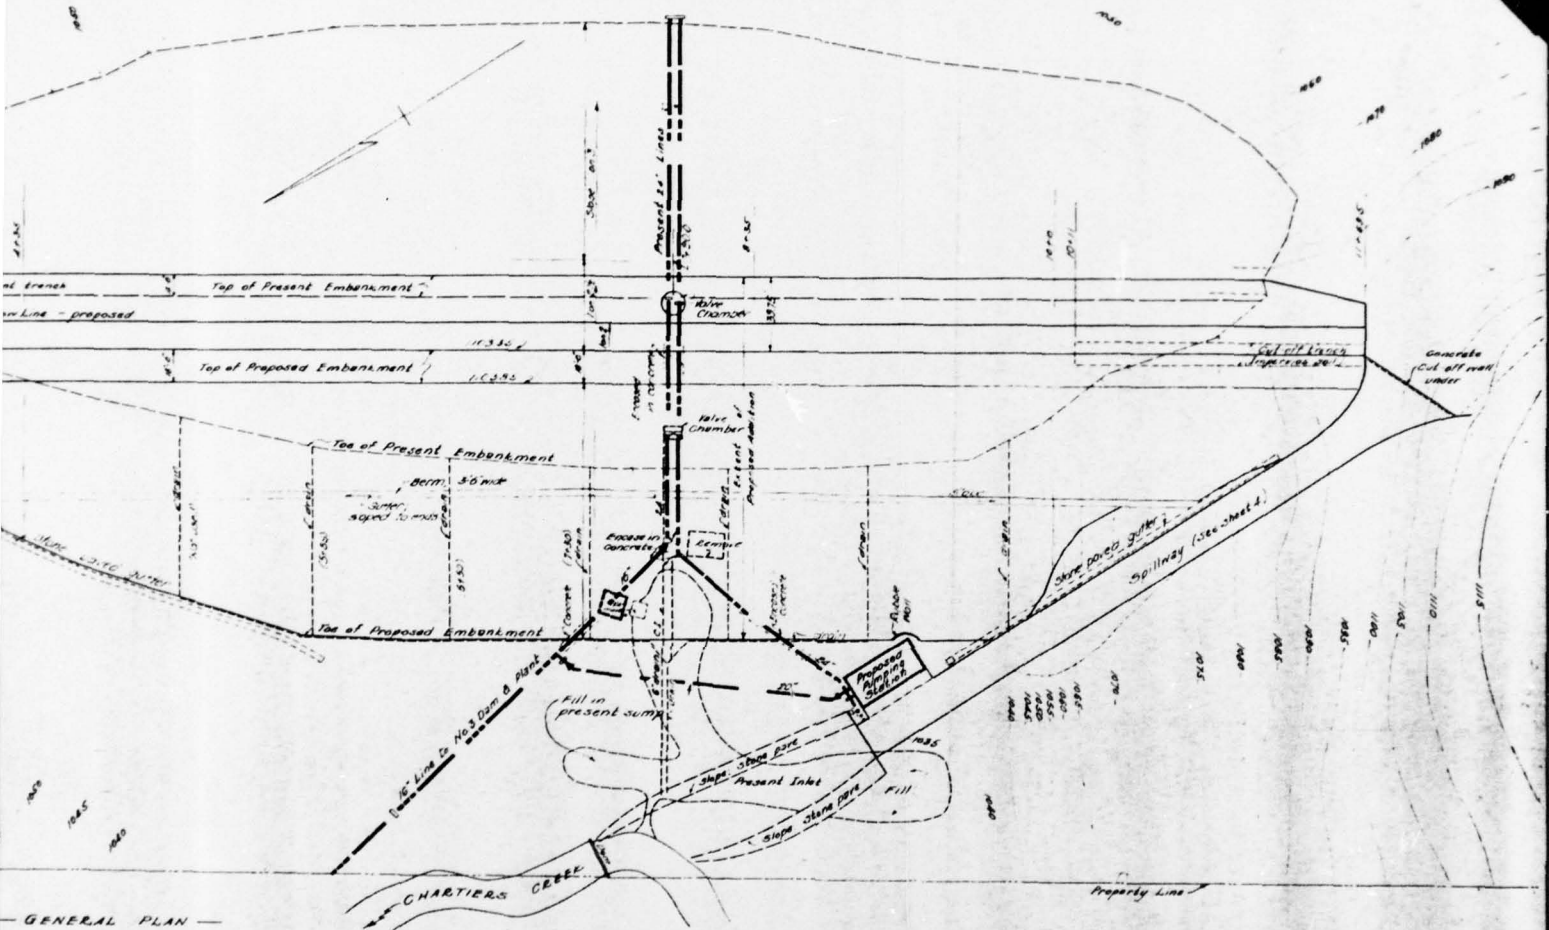
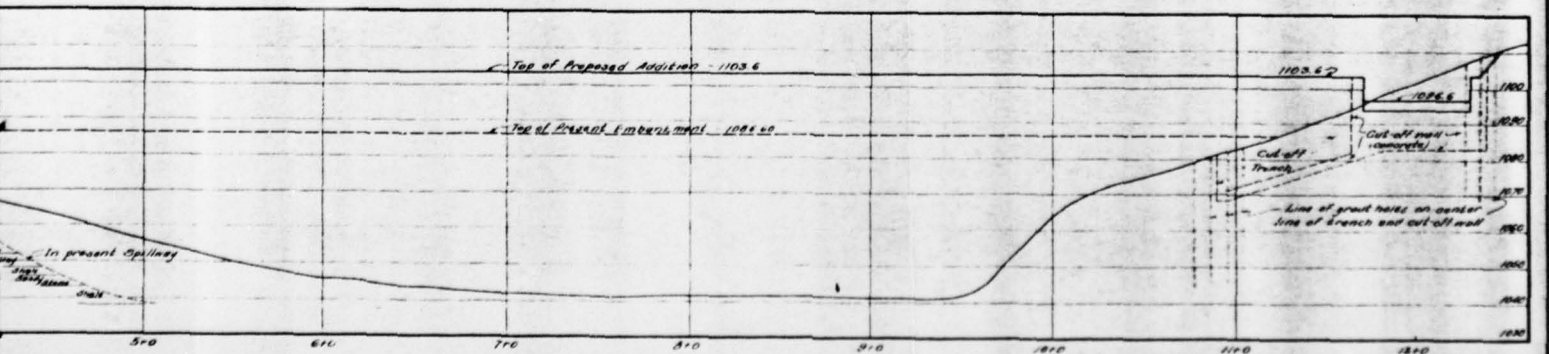
FIGURE 2

Zoning - Earth embankment reportedly rolled in 6-inch layers consisting of impervious materials between the upstream face and the central core increasing in permeability from the central core to the downstream face. The upstream face is covered with crushed stone and/or slag and a rock-fill was placed at the downstream toe. Drawings also indicate drainage laterals at 75-foot centers extend from the downstream toe to the toe of the old embankment (see Figures 2 and 3).

Type - Two 24-inch cast iron pipes encased in concrete pass through the embankment. One line is reduced to 16 inches near the toe of the embankment and gravity feeds the filtration plant. The other line enters the pump house and has a 16-inch blow-off tap that discharges into the spillway stilling basin. The latter line actually functions as a supply line to the reservoir from the pump system which draws water from Chartiers Creek (see Figures 2 and 6).

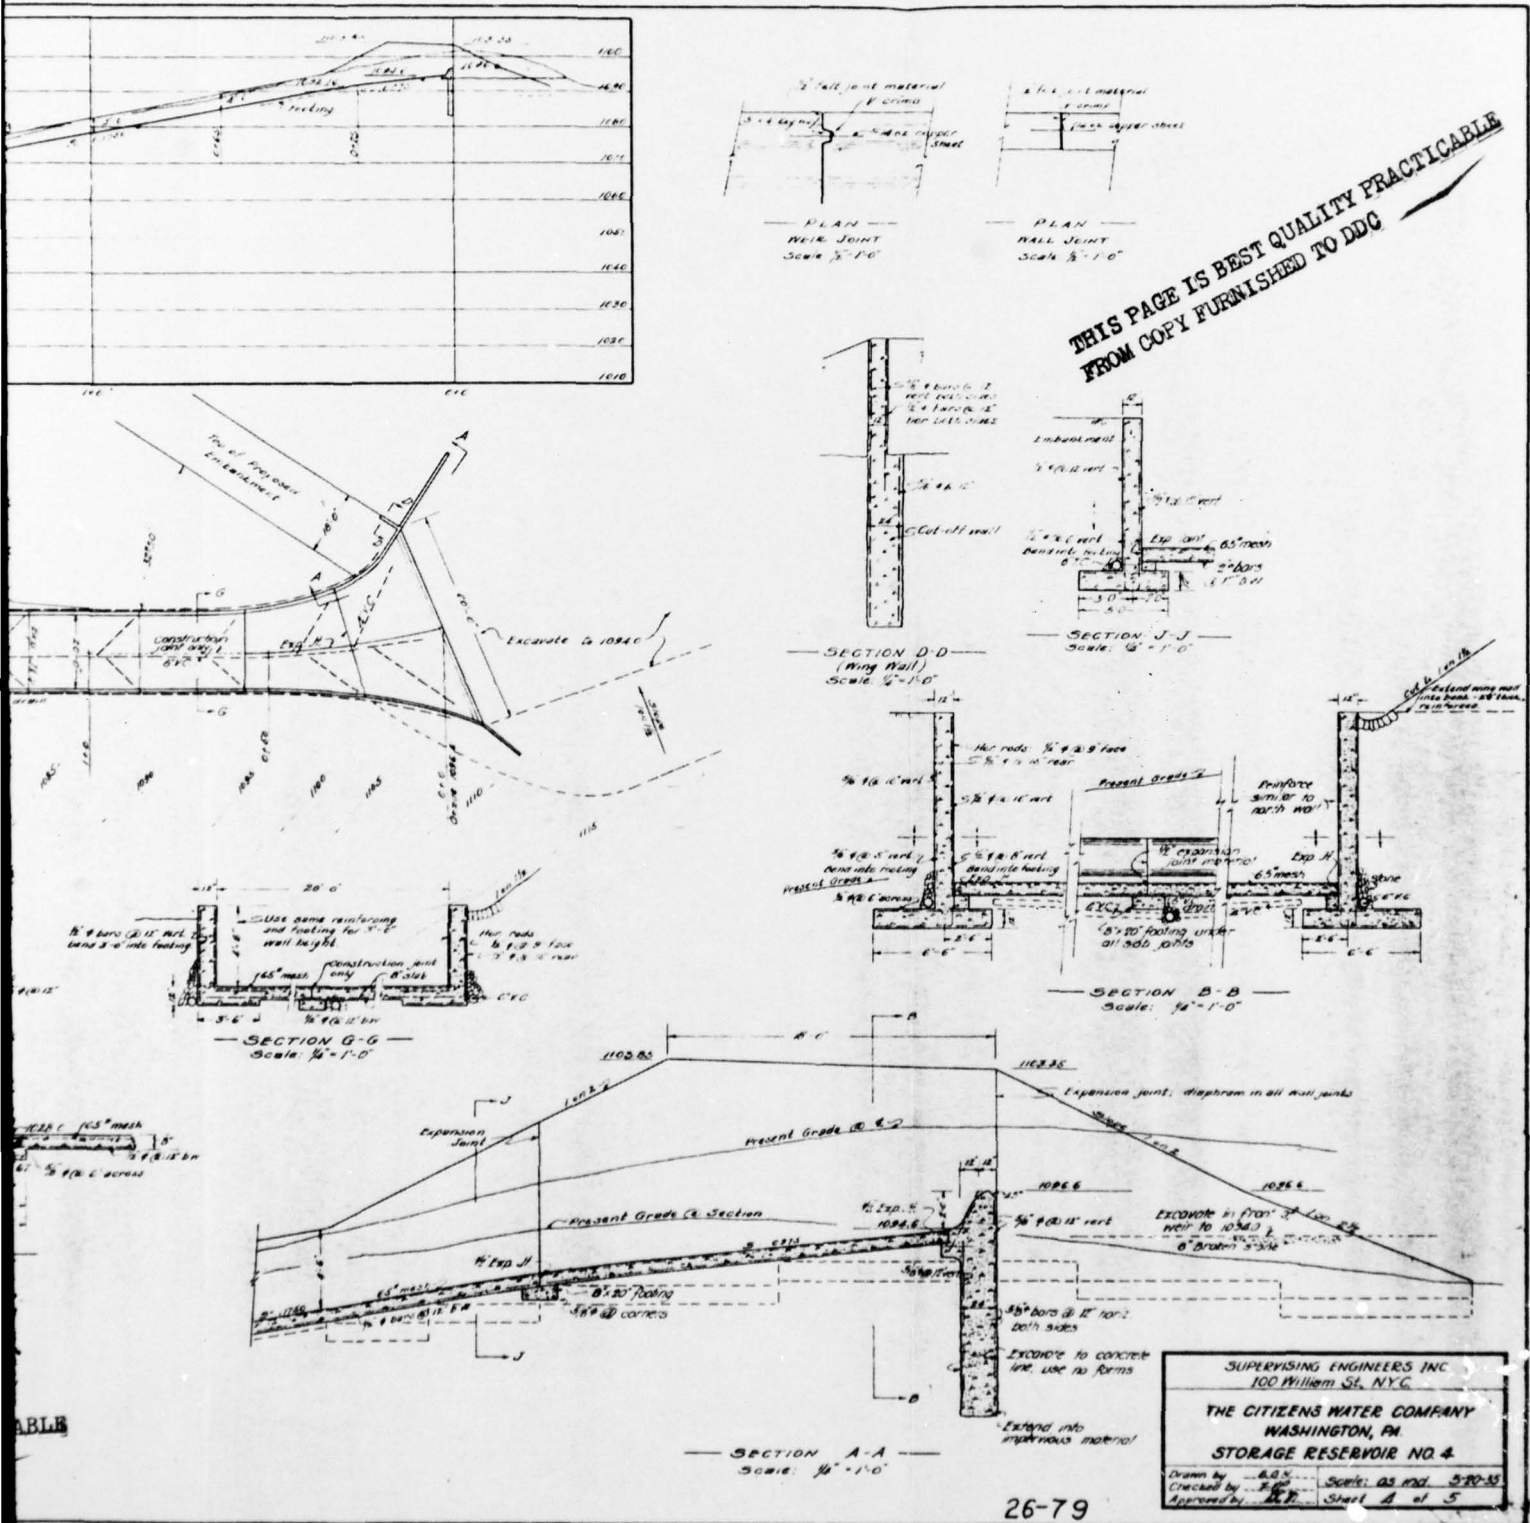
FIGURE 4

a) Spillway. The primary discharge is a reinforced concrete ogee spillway located adjacent to the left abutment (see Figure 4 and Photographs 5 and 6). Drawings indicate the spillway slab is keyed into impervious material at the entrance as shown on Figure 4. French drains extend along the outside base of both wing walls to divert water away from the spillway footings. In addition, there are drains beneath the spillway slabs, the main collector of which emerges through the concrete chute at approximately 50 feet above the stilling basin. The stilling basin is located adjacent the pump house at the base of the left abutment.
